Subject: Structural Engineering Report – Arena Roof

**ARENA ROOF**

**STRUCTURAL ASSESSMENT REPORT**

**PROJECT NO: 19-104**

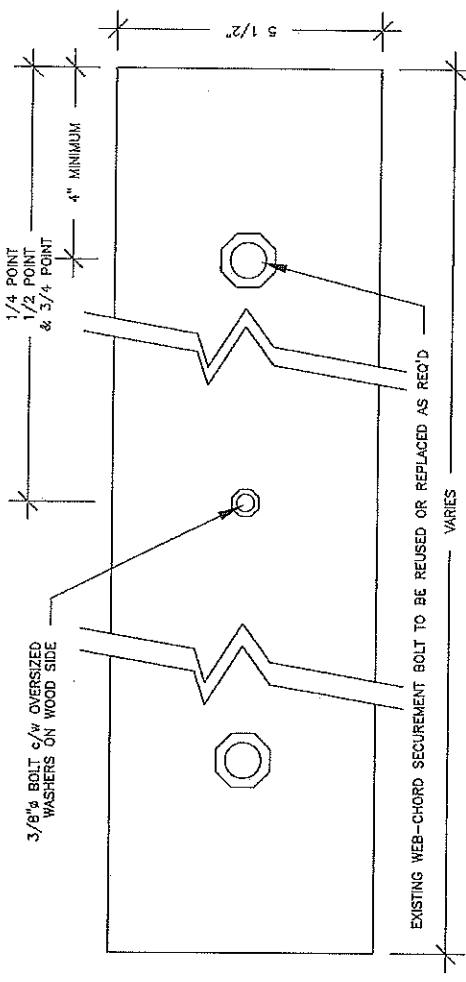
3/8" PLATE DETAIL

Checked members have a reduced resistance to shear and tension/compression loads and require reinforcement to assist the member to bear its load and reduce the rate of further deterioration. Banding is performed to reinforce compression members, and plating of tension members removes the tension from the wood member and transfers it to the steel plate.

**P** – This web member requires reinforcement with a 5 1/2" x 3/16" thick Galvanized Steel plate the length of the tension web member. Site measurements will be required. This plate is to be secured at the ends using the existing web-chord securement bolts (threads not intercepted) and at the ¼ points with 3/8" dia. Galvanized Steel Bolts complete with oversized washers. Refer to drawing SK-1 for fabrication details of the plate. If the existing web-chord steel bolts are not reusable they are to be replaced with matching galvanized bolts, nuts and washers.
